## A Case of Osteomyelitis in Patient with Remaining Assist Device Driveline after Heart Transplantation: A Case Report

Harmel E<sup>1\*</sup>, Barten MJ<sup>1</sup>, Philipp S<sup>2</sup>, Rybczynski M<sup>1</sup>, Reichensperner H<sup>1</sup> and Sill B<sup>1</sup>

<sup>1</sup>Department of Cardiac Surgery, University Heart Center Hamburg, Germany

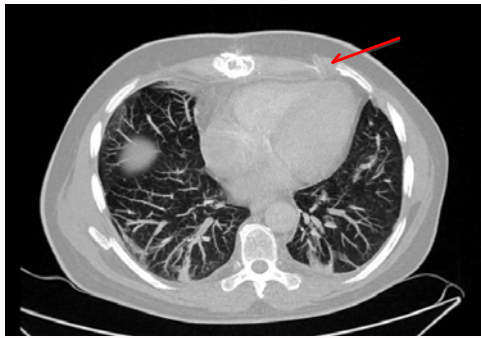
**Figure 1:** CT scan showing remaining driveline in close location to the right ventricle.

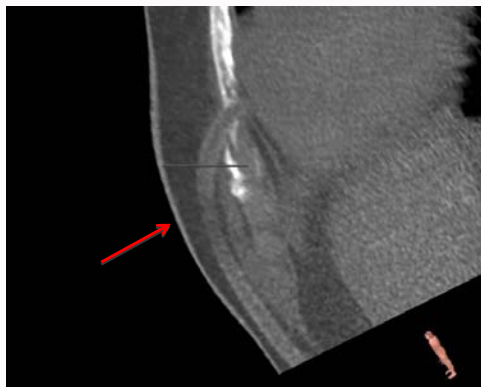
**Figure 2:** Reconstruction model (3 mension) of the remaining piece of driveline in location to the leftsided 4th to 5th intercostal space.

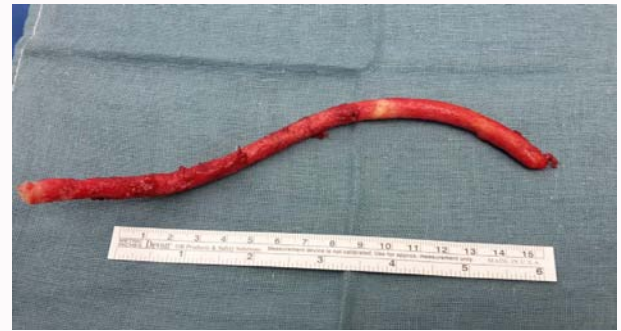
**Figure 3:** Remaining piece of driveline after operative removal.
