## A Case of Osteomyelitis in Patient with Remaining Assist Device Driveline after Heart Transplantation: A Case Report

Harmel E<sup>1\*</sup>, Barten MJ<sup>1</sup>, Philipp S<sup>2</sup>, Rybczynski M<sup>1</sup>, Reichenspurner H<sup>1</sup> and Sill B<sup>1</sup>

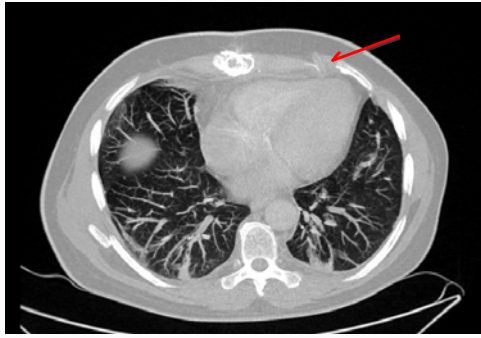
**Figure 1:** CT scan showing remaining driveline in close location to the right ventricle.

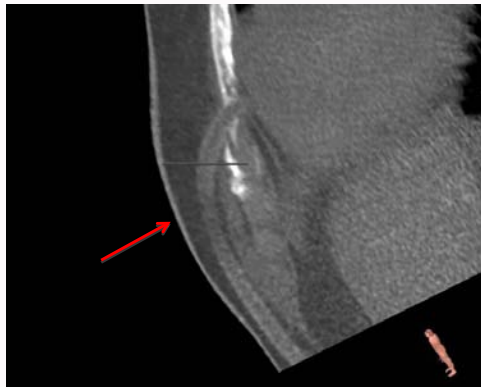
**Figure 2:** Reconstruction model (3 mension) of the remaining piece of driveline in location to the left-sided 4th to 5th intercostal space.

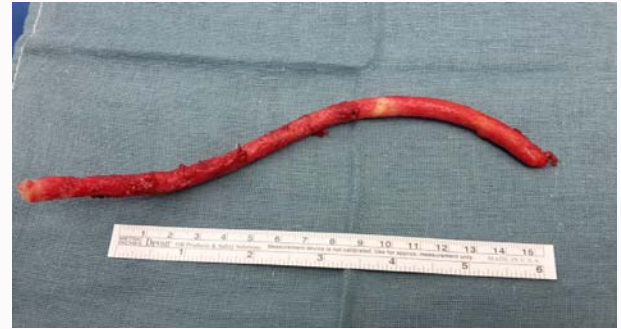
**Figure 3:** Remaining piece of driveline after operative removal.
