## Fixation Failure of a Volar Wrist Plate Following a Fall from a Standing Height

Hind J, McGrath J, Kitsis C, Ashwood  
N. Fixation Failure of a Volar Wrist Plate  
Following a Fall from a Standing Height.  
*Ann Clin Case Rep.* 2020; 5: 1875.

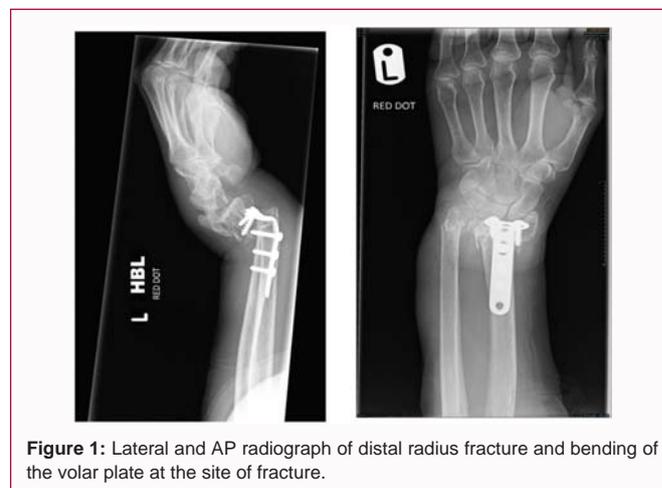
**Figure 1:** Lateral and AP radiograph of distal radius fracture and bending of the volar plate at the site of fracture.

was normal. She had good palpable pulses and her capillary refill time was normal. Her median and ulnar nerve function was preserved. An X-ray of the left wrist was performed. The case was discussed in the local trauma meeting and it was decided to take the patient to theatre to remove and replace the internal fixation plate. She was taken to theatre the following day. A Henrys approach was performed and a soft tissue dissection was performed to the plate. The plate was bent at the level of the unused hole and the distal screws had avulsed from the distal radius. The plate was removed which revealed a severely comminuted fracture. The fracture was reduced and alignment confirmed on image intensifier before a bridging volar Acu-Loc plate was applied and fixed with a combination of locking and non-locking screws. A fasciotomy of the flexor compartment of forearm was also performed to manage what appeared to be an impending compartment syndrome and a carpal tunnel release was performed to avoid a carpal tunnel syndrome. The flexor compartment of the forearm was swollen but not necrotic and the median nerve and the thenar branch were identified and preserved. Postoperatively the patient managed well and was discharged home with a backslab *in situ*. She was seen in follow up clinic at 2 and 6 weeks postoperatively with numbness over the thumb, middle and ring finger suggestive of some damage to the median nerve despite preservation efforts. We cannot determine at this moment if these symptoms will be reversible or not.

This case is unusual in that the plate failed as a result of trauma from a fall. Volar plates are known to fail due to loosening or breaking of the screws as well as bending or breaking of the plate [8]. However, bending of the plate typically occurs as a result of stress fractures that are caused by damage over time, as opposed to acute trauma [5]. Repetitive use of the wrist, particularly if patients use their wrists to assist standing, has been shown to cause both titanium plates and the screws to break [9,10]. In the elderly, prolonged stress is more likely to weaken the hardware to the point of breaking [11]. Osteoporosis, obesity and muscle wasting can also contribute to hardware failure [11].
