Percutaneous Extraction of the Completely Fractured Guiding Catheter from the Tortuous Iliac Artery by using Goose Neck Snare

Abstract

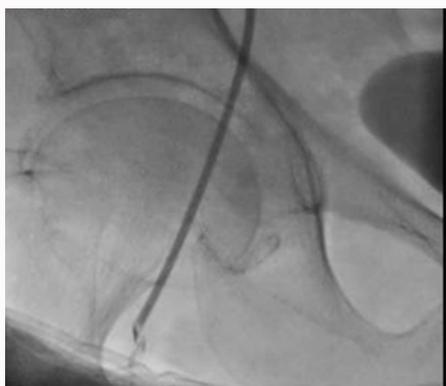
We tried to correct the knotting by twisting the catheter in counterclockwise direction and advanced 0.38" guide wire through the catheter to correct the knotting. At this moment we realized that the catheter was ruptured near the proximal portion of right iliac artery (Figure 1). To remove the ruptured segment of the catheter we replaced 6F femoral sheath with a wider 7F sheath. At first we tried to catch the end of the catheter with an endomyocardial biptome forceps, but our attempt was unsuccessful. We decided to use Gooseneck snare and finally we succeeded to catch the

Figure 1: Catheter was ruptured near the proximal portion of right iliac artery.

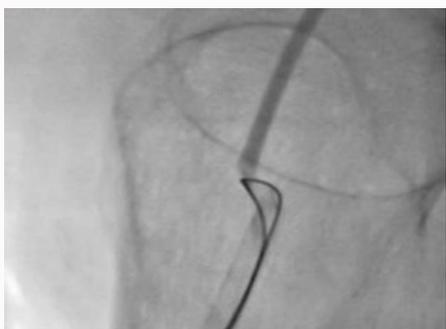
Figure 2: Ruptured catheter from its portion near to femoral artery and removed through the large femoral sheath.

ruptured catheter from its portion near to femoral artery and removed through the large femoral sheath (Figure 2). Two units of packed red blood cells were transfused to the patient due to the decrease in her hemoglobin level down to 9 g/dl and after transfusion, hemoglobin level was increased to 11 g/dl. No source of the bleeding was seen in thoracic and abdominal CT angiography.
